CALIFORNIA DIVISION OF MINES AND GEOLOGY  
FAULT EVALUATION REPORT FER-145

Faults East of Bakersfield, Kern County

February 6, 1984

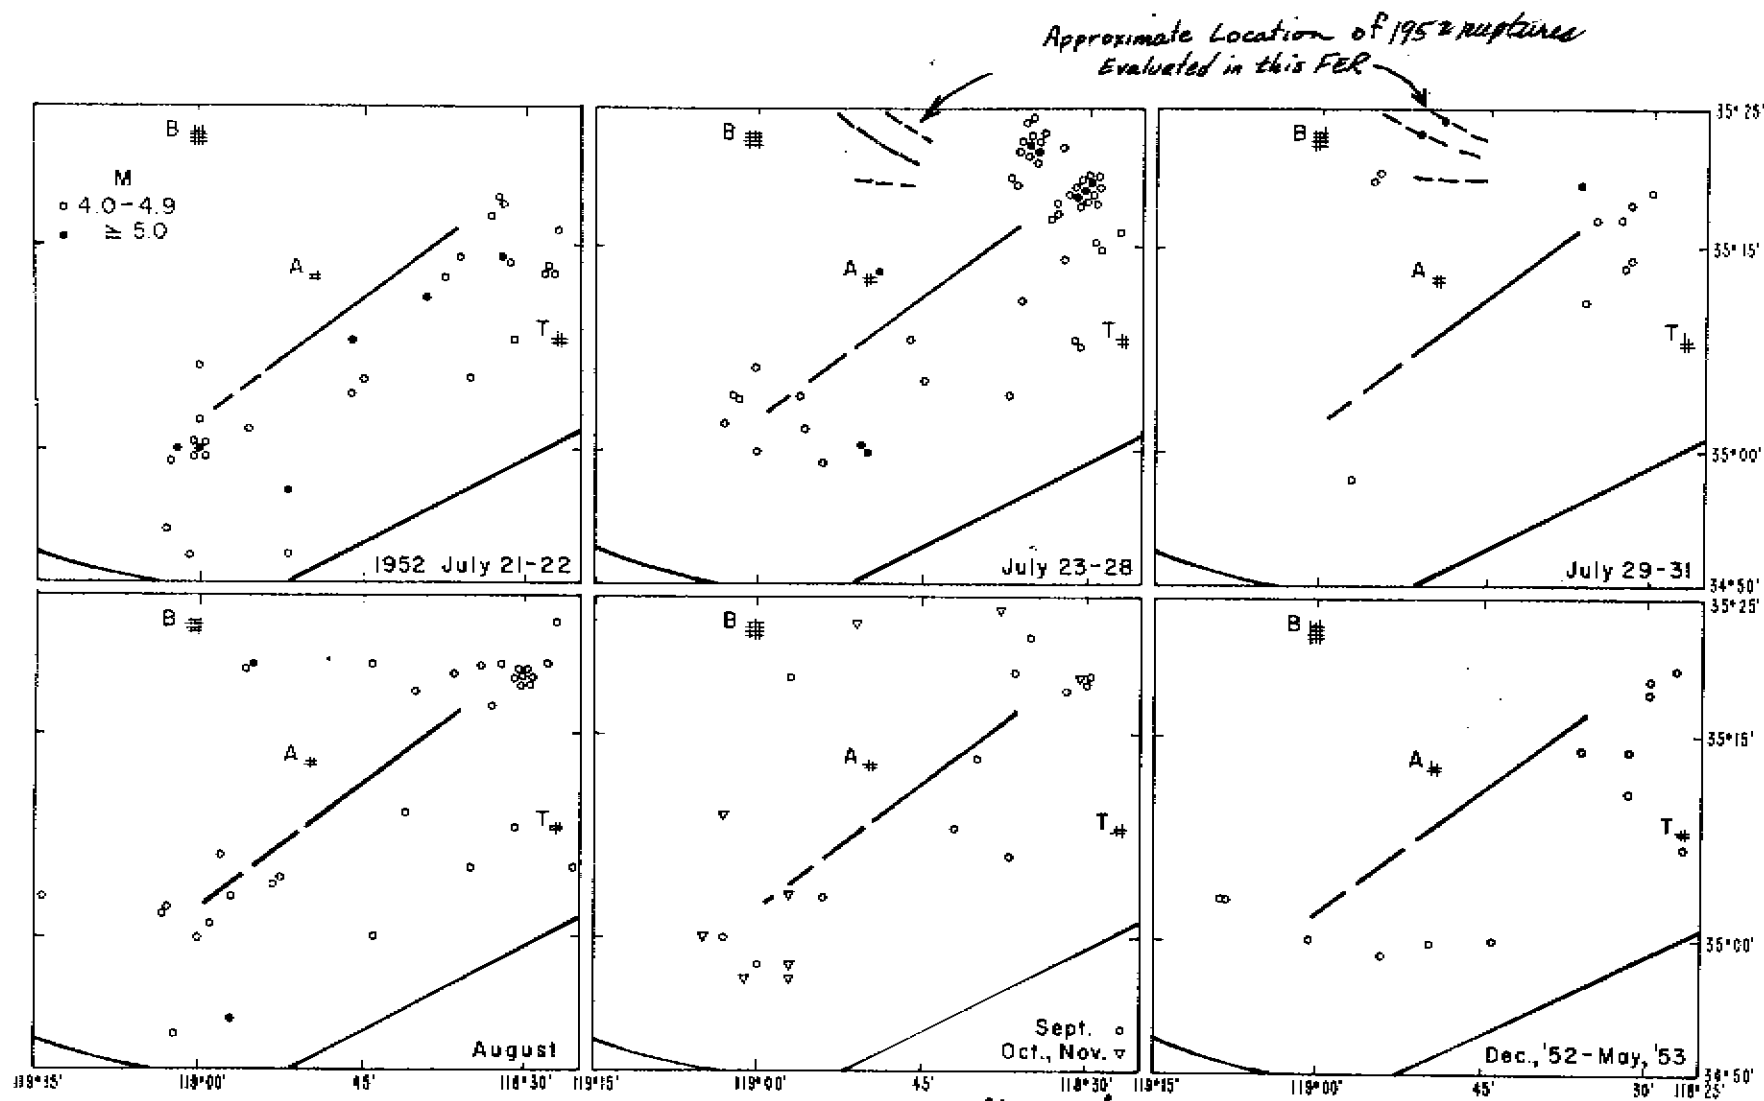
FER-145. Figure 4. Epicenters of earthquakes magnitude 4.0 and larger (from Richter, 1955).

The proximity of the 1952 fault breaks evaluated herein to the large aftershocks is suggestive of a cause and effect relationship (see Figure 4). However, Bruer (oral communication, 1983) indicates that the ruptures in this area were found after the July 21 earthquakes and before the July 28-29 earthquakes. It is conceivable that ground rupture east of Bakersfield may have been associated with more than one earthquake.

FIGURE 2. Epicenters of located shocks of magnitude 4.0 and over: (a) 1952 July 21 11:52—July 23 00<sup>h</sup>; (b) July 23 00<sup>h</sup>—July 29 00<sup>h</sup>; (c) July 29-31; (d) August; (e) September, October, November; (f) December 1952 through June 1953.

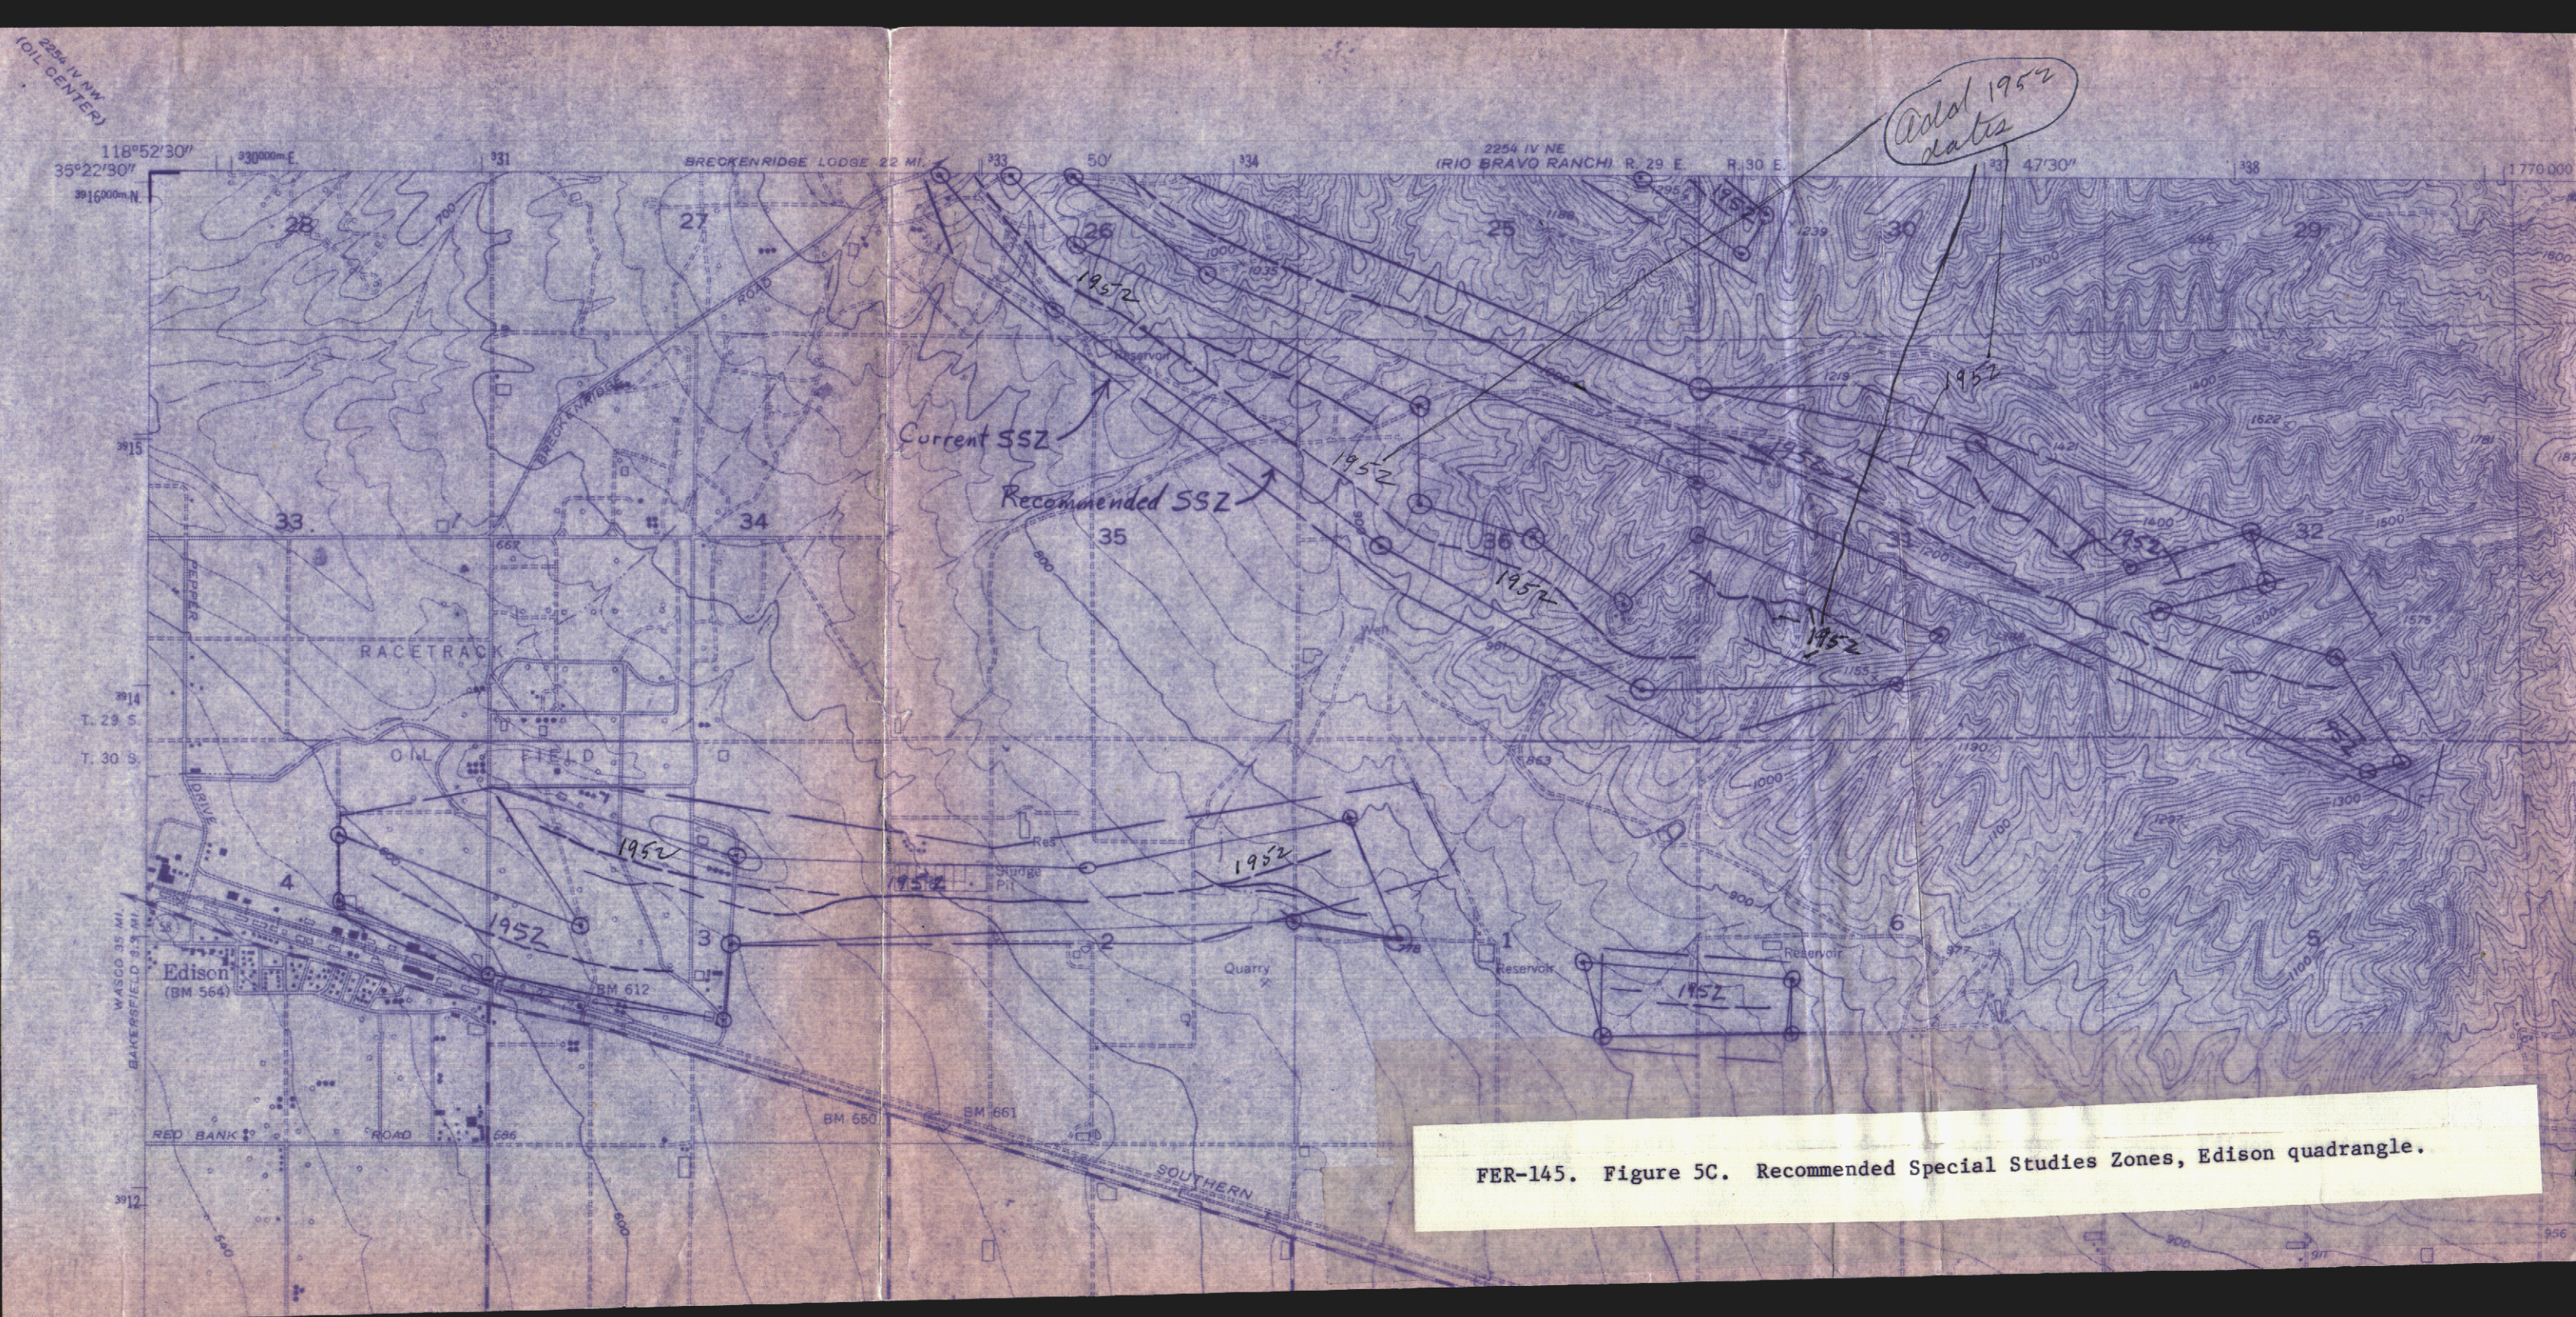
FER-145. Figure 5B. Recommended Special Studies Zones, Rio Bravo Ranch quadrangle.

It appears that some of these recently active faults extend beyond the boundaries of the Special Studies Zones, especially in the area northwest of State Highway 178. This conclusion is primarily based on the presence of geomorphic features (principally scarps) similar to those found along some of the 1952 fissures which were later confirmed by trenching to be faults. Indeed, some of these scarps are actually extensions of scarps that have been trenched and found to coincide with normal faults. Based on the similarity (particularly the degree of dissection) of the scarps trenched to those reasonably well-defined scarps not yet zoned, it appears likely that movement has occurred along these unzoned extensions during Holocene time, and almost certainly occurred during latest Pleistocene time.

Based on the above information and conclusions, revision of the existing SSZ maps of the Oil Center, Rio Bravo Ranch, and Edison quadrangles appears warranted. Figures 5A, 5B, and 5C show the recommended revised zones. Bruer, Robinson, and others (1952) and this FER should be the principal references cited.
